LCA Environmental Consultants

**Re: Violation Notice 1-1VTUJB; Response to MECP Correspondence
Nickel Beach, Port Colborne**

APPENDIX A
Site Photographic Records

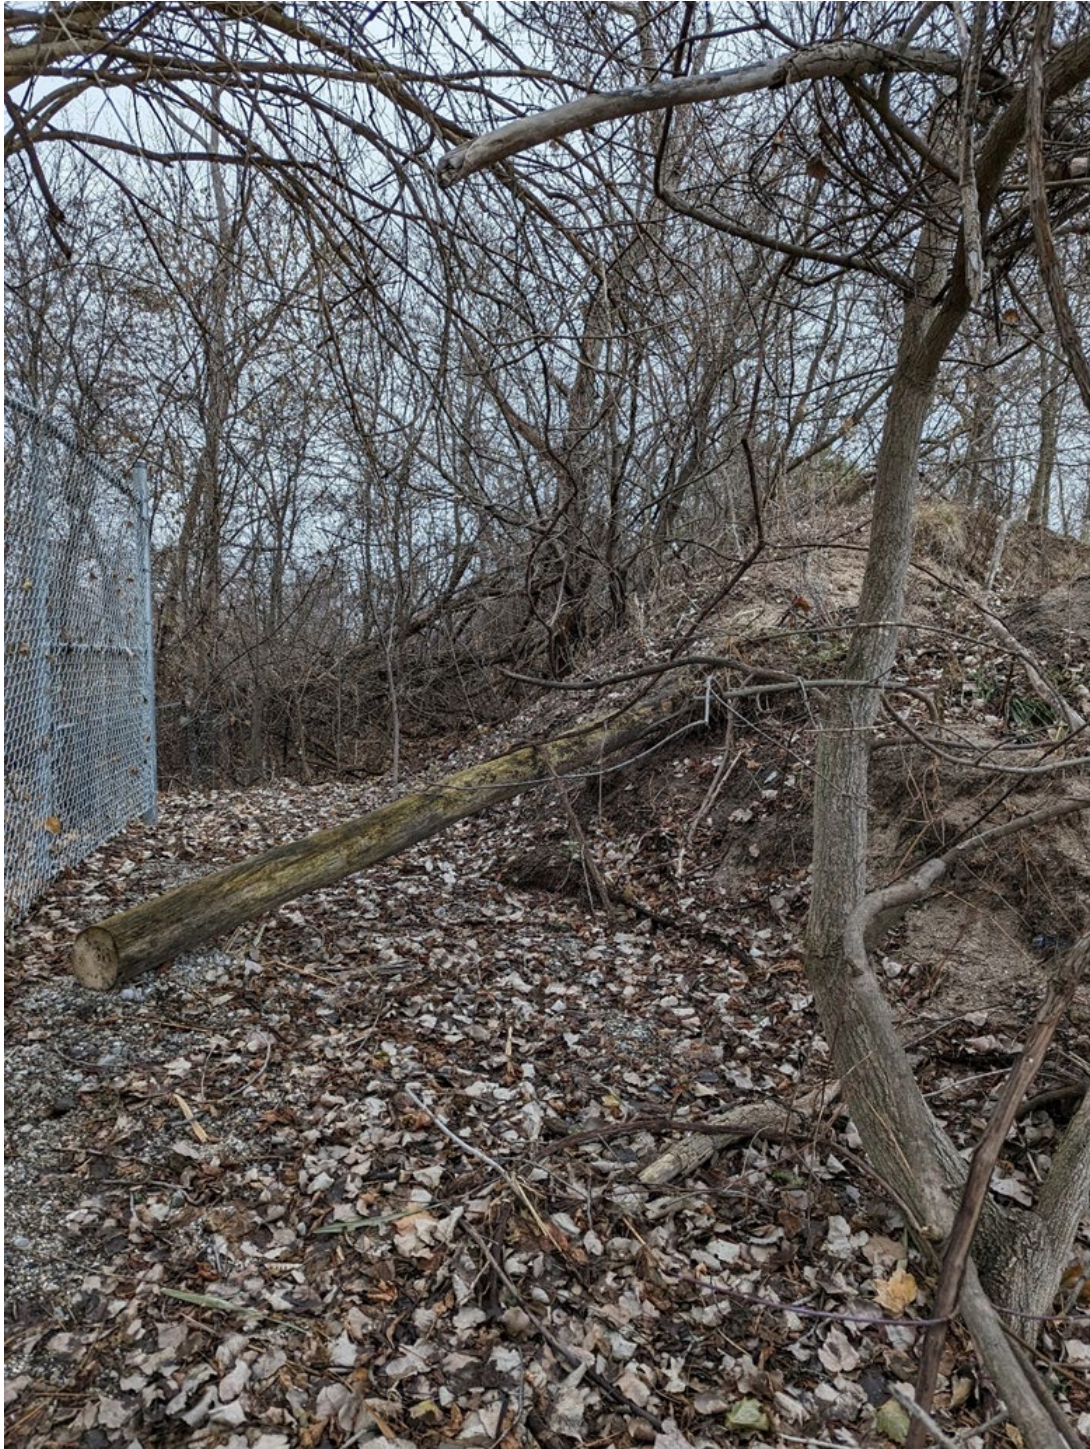
Photograph 1: Large fill pile taken from south side of the pile from inside new fencing.

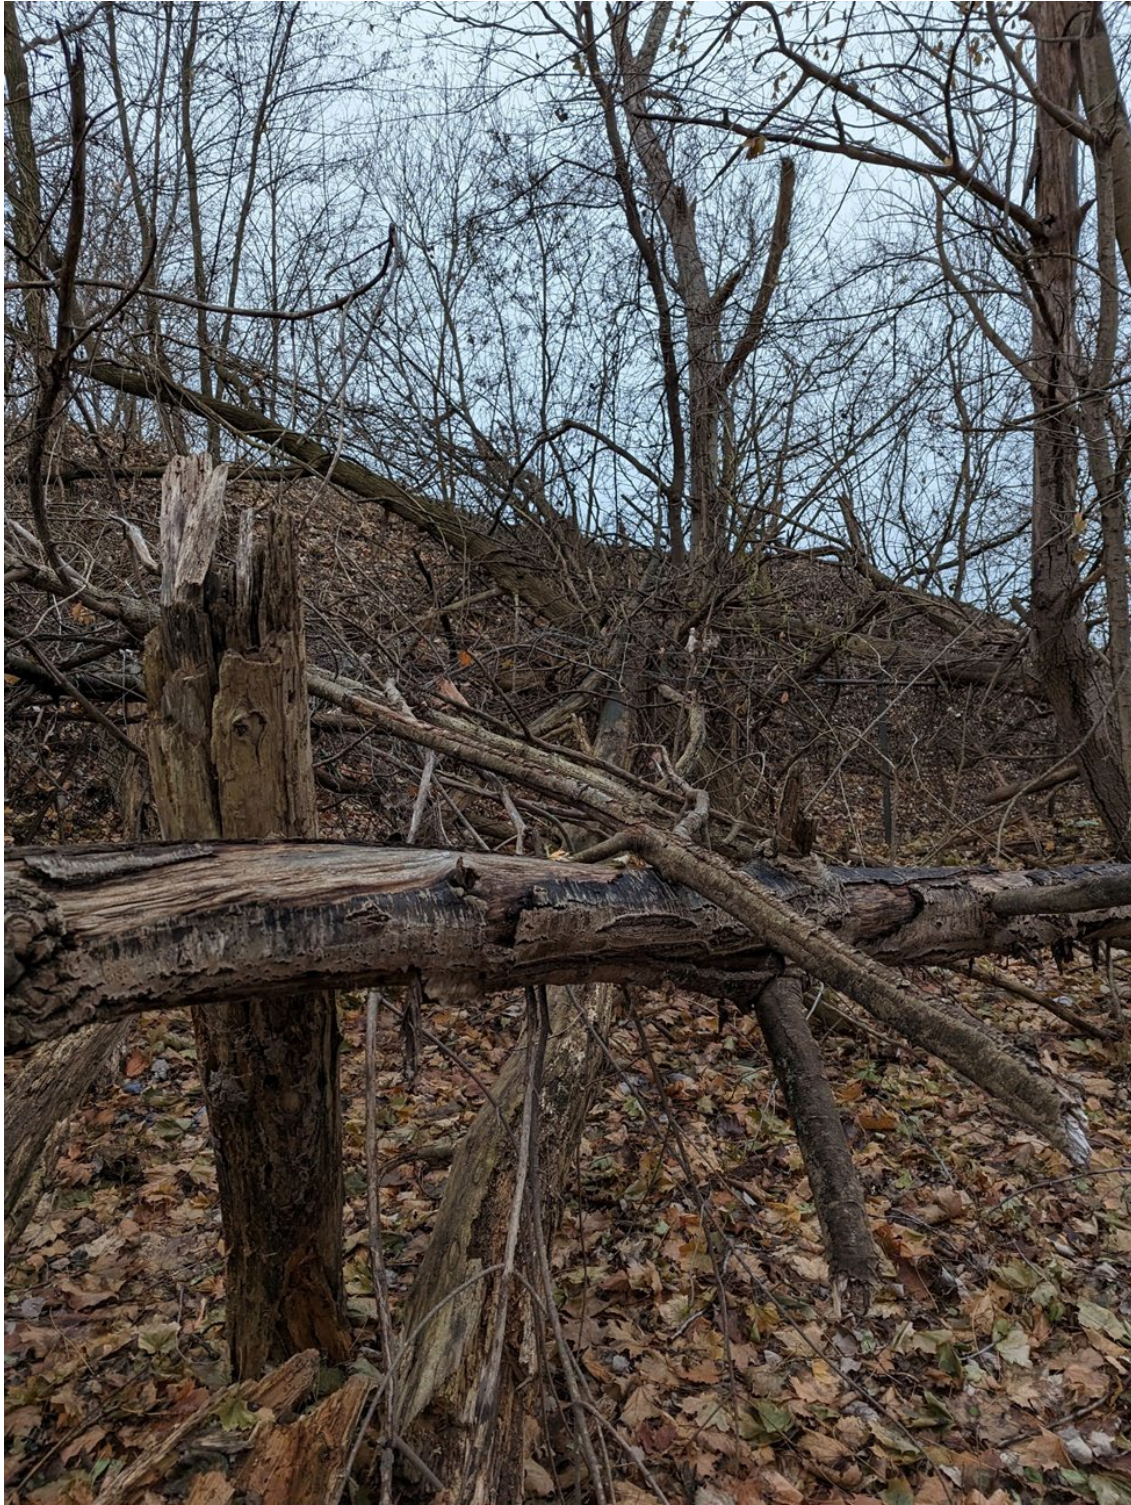
Photograph 2: Photo of fill pile adjacent to existing fencing. Fence seen in centre of photo. Image capture from west of the pile.

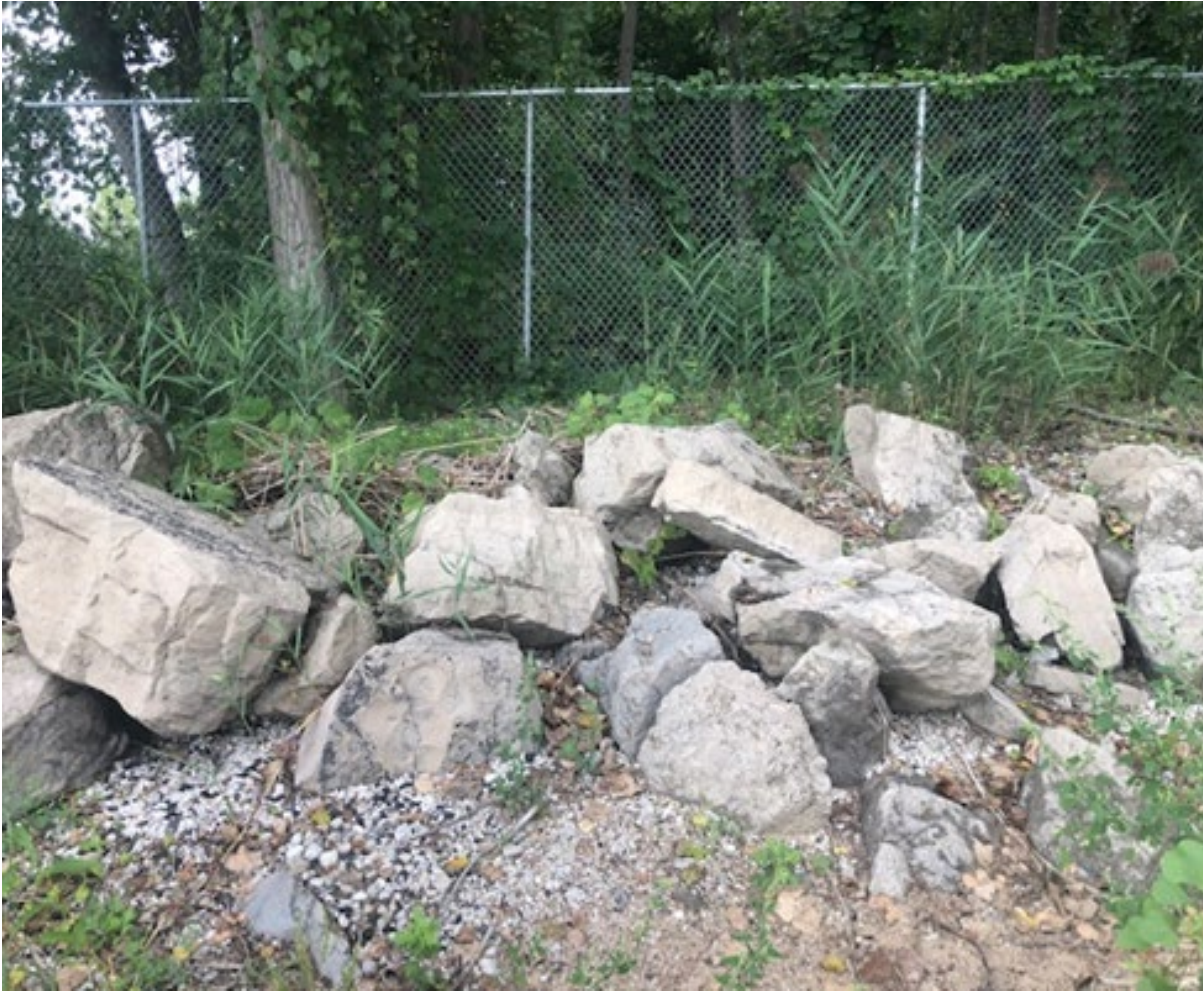
Photograph 3: Rocks and berm at the foundation of the replaced western fence.

private lands and uses as per the current lease agreement between Vale Canada Inc. and the City of Port Colborne. The earthen berm and rocks at the base indicate that the historical placement of these materials was for separation from the adjacent industrial uses. The fence serves both to delineate the property limits, as well as, providing a safety measure for beach patrons and to limit trespassers from entering the beach after hours.

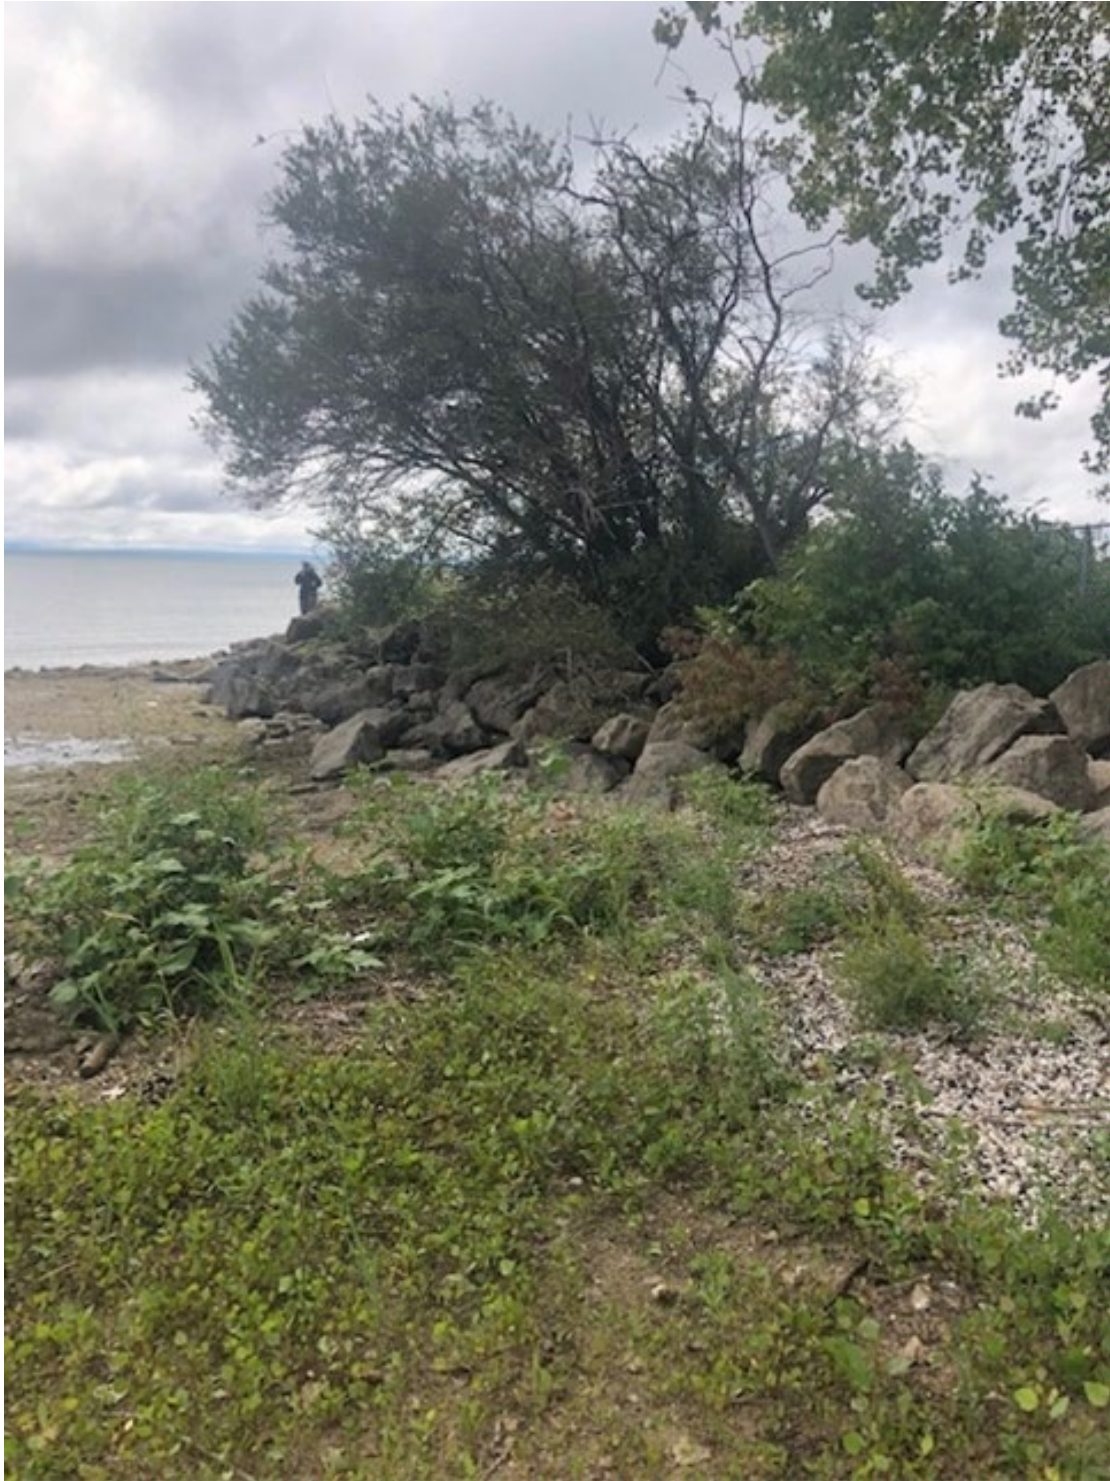
Photo 4: Extent of earthen berm that delineates the western limit of the leased beach area.

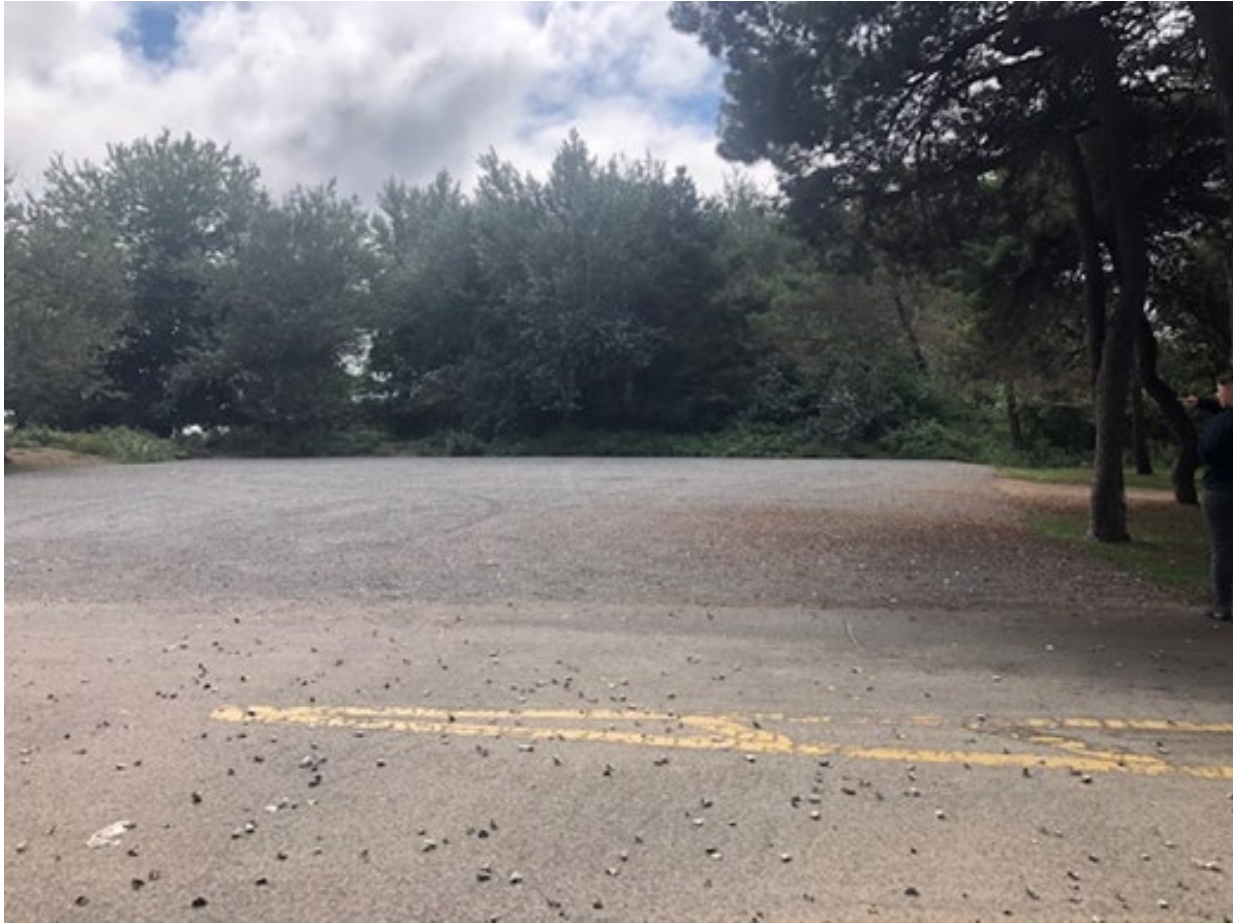
Photograph 5: Gravel area west of entrance access road to be restored with the native bermed material at the western lot perimeter.

- i) Scrape to remove the gravel and stockpile offsite (outside of the entrance gates or at a City yard) for future use as needed;
- ii) Spread the bermed materials (originally from that location) back across the site to emulate the pre-construction condition;
- iii) A rope fence along the entrance road at the western limit will protect so that no one disturbs the area or inadvertently parks there in the future.

The timing of these remedial works is recommended through the winter months between January 1, 2023 and March 15, 2023 to ensure that the works are completed prior to any Fowler Toad movement in the spring. As the area is currently compacted and not suitable for Fowler Toad hibernation, there are no concerns with completion of the works through the winter months. The berm, as well, is not suitable for hibernation as there is not suitable depth (below frost line) for hibernation of the toad. The spreading of the native topsoil will also disperse the seeds and roots of the vegetation that existed in the area pre-construction which the vegetation is dormant. Any non-native organic debris should be removed from the area at the time of the works to minimize the rooting and growth of non-native species in this area.

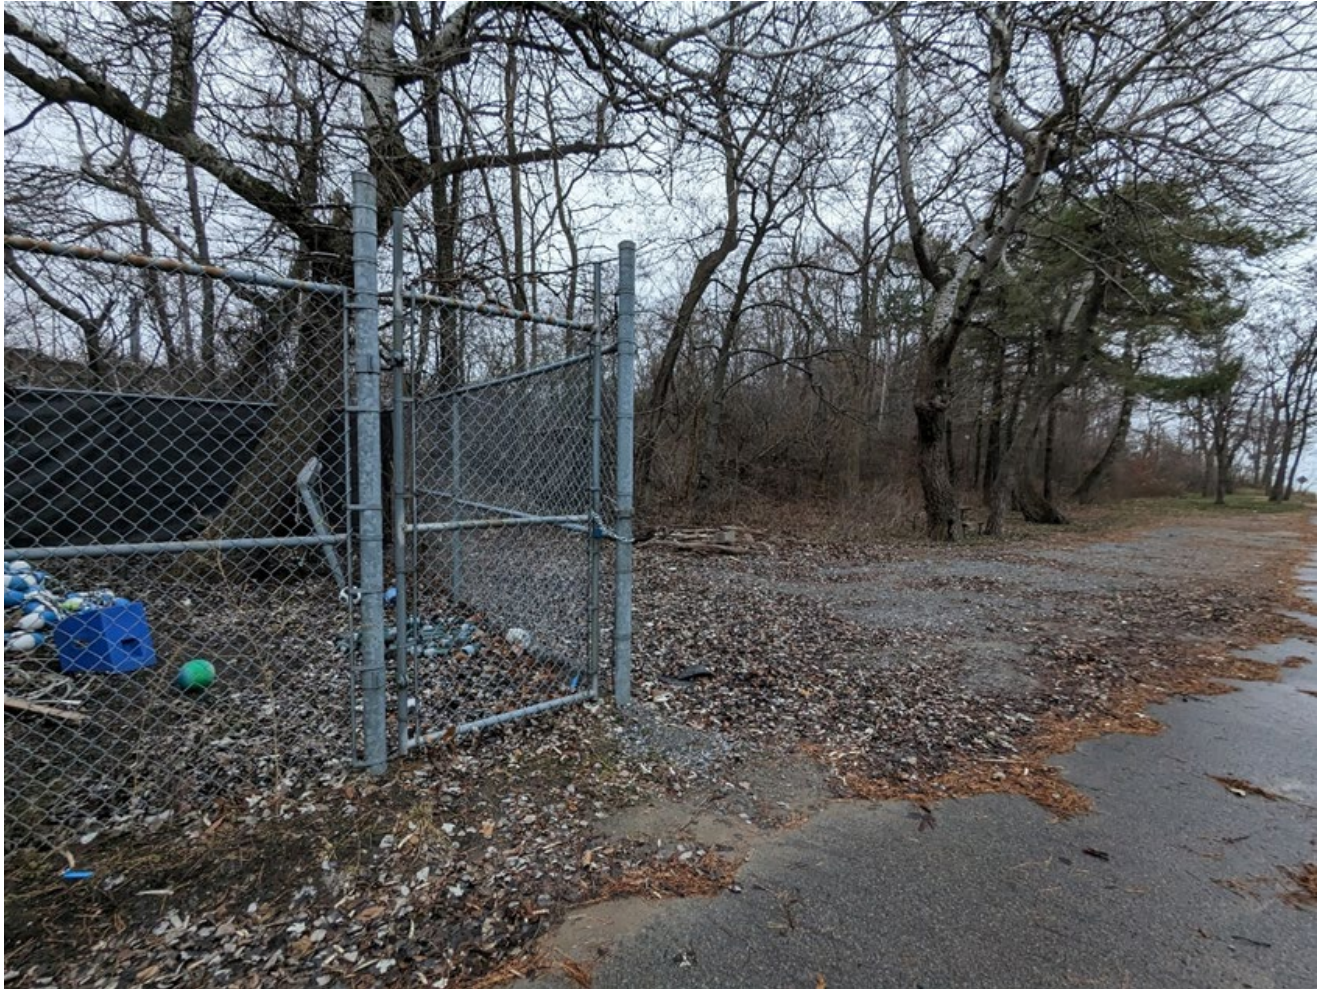
Photograph 6: Existing conditions along the east side of existing access road.
