City of Port Colborne Town of Fort Erie

**Project No: EWB-199997** Copyright © 2021, all rights reserved

Title: Point Abino Drain Baseline Report Submission Date: December 16, 2021

Paul C. Marsh, P.Eng. EWA Engineering Inc. Principal Engineer

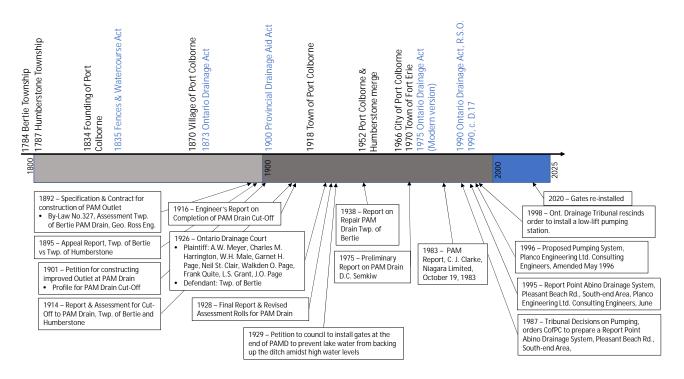
Figure 1 Point Abino Marsh Drain History Timeline

- 1892 Specification & Contract for construction of Point Abino Marsh Outlet
  - By-Law No.327, Assessment Twp. of Bertie, Point Abino Marsh Drain, Geo. Ross Eng., July 16th
- 1895 Appeal Report Twp. of Bertie vs Twp. of Humberstone
- 1901 Petition for constructing improved Outlet at Point Abino Marsh Drain
  - Profile for Point Abino Marsh Drain Cut-Off, May 7th

- 1938 Report on Repair Point Abino Marsh Drain Twp. of Bertie, Mar 10th
- 1975 Preliminary Report on Point Abino Marsh Drain, D.C. Semkiw, Feb 5th
- 1983 C. J. Clarke, Niagara Limited, dated October 19, 1983, which report was adopted by the Council of Fort Erie and the Council of the City of Port Colborne in accordance with By-law 64-84 of the Town of Fort Erie and By-law 1420/83 of the City of Port Colborne

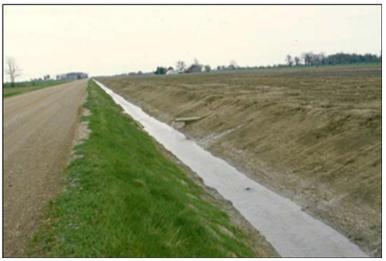
Figure 4 Example of clear drain

The objective of a drain is to provide a clear unobstructed flow with depth to provide adequate private drain connection outlets. The following image exemplifies a traditional "good" drain profile and cross-section with contributary flows from a tile drain connected to the drain.

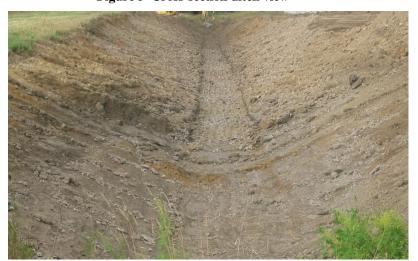
Figure 5 Cross-section ditch view

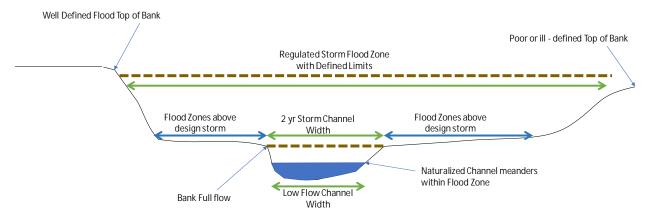
Figure 7 Naturalized Channel cross-section

The following figure illustrates a naturalized channel design approach to a ditch or creek channel.

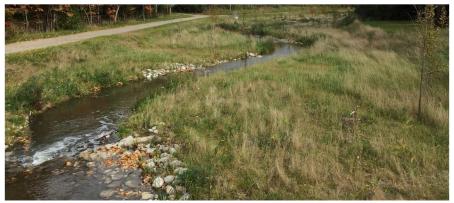
Figure 8 Naturalized Channel with Pools and Riffles

A naturalized channel design has the following features:

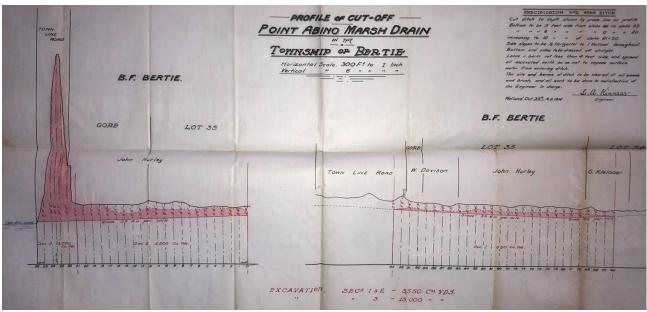
Figure 9 Point Abino Marsh Drain Profile for Cut-Off -1901-1914

1914 Profile of Cut-off Point Abino Marsh Drain

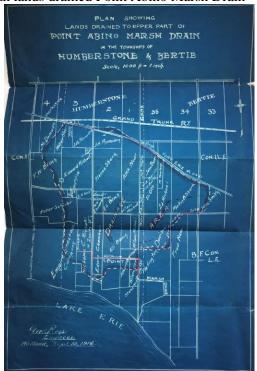
Figure 10 Point Abino Marsh Drain Plan View - 1915

**1915** Plan lands drained Point Abino Marsh Drain

The drain extends to the west as far as midway of Lot 3 Humberstone. The outlet is shown proceeding to the lake at the Townline Rd. between Bertie and Humberstone.

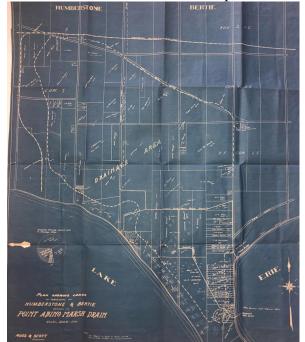
Figure 11 Point Abino Marsh Drain Plan View - 1925

**1925** Plan Point Abino Marsh Drain – Proposed Auxiliary Drain Outlet

Shows the existing outlet as being just south of Erie Road off of Point Abino Rd. Hurley cut off is shown as the outlet along Townline Rd. Proposed alignment for new outlet is shown as proposed and different from 1927 report.

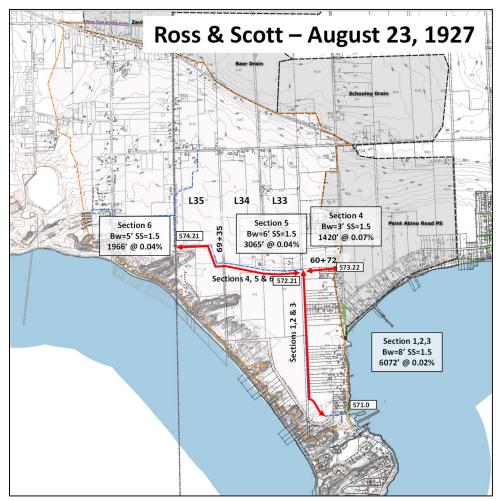
Figure 12 Drain Composition 1927

This is the beginning of the modern Point Abino Marsh drain. Before this work, the drain had its outlet along Point Abino Road approximately where the Point Abino Rd Pumping Station is presently located.

- Segments 1, 2 and 3 were composed of 6072 ft at 0.02% with a bottom width of 8 ft.
- Segment 4 reversed the east portion.
- Segments 5 and 6 extended west to Holloway Bay Rd. Segment 5 with a 6 foot bottom and segment 6 with a 5 foot bottom and both at 0.04% slope.

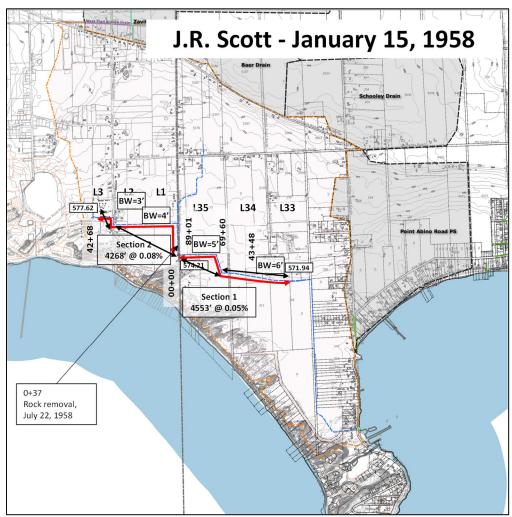
Figure 13 JR Scott Drainage Works 1958

In 1958, the Engineers Report extended the drain westward and re-graded original sections 5 and 6 into new sections 1 and 2 with increased grades 0.05% and 0.08% respectively. This also included some rock removal along the north section parallel to Holloway Bay Rd.

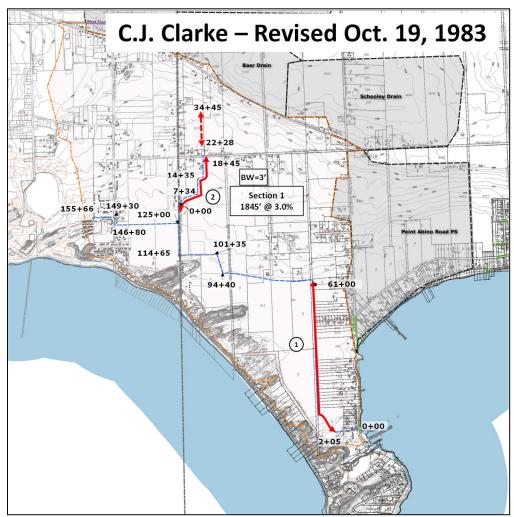
Figure 14 CJ Clarke Drainage works 1983

The Clarke works of 1983 is the last updated and recorded watershed boundary, used later to allocated costs from future reports. Also there were two segments of work completed.

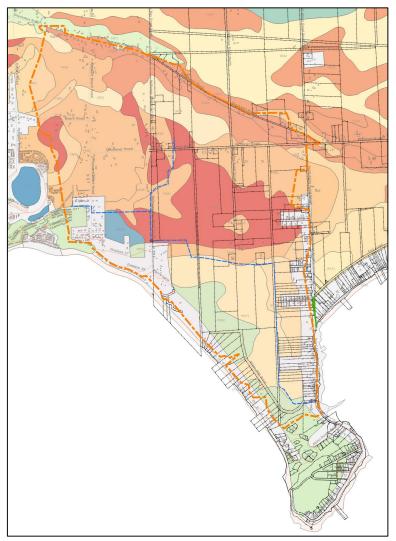
Figure 16 Point Abino Watershed Soils

The uplands zone features soils with lobes of Chingcousy, Farmington and Franktown (light shades) around a central Brooke soil. The grey is a series labeled 'not mapped' and is generally representative of the residential areas along the Lake Erie shoreline, which was deemed unsuitable for farming and thus not mapped.

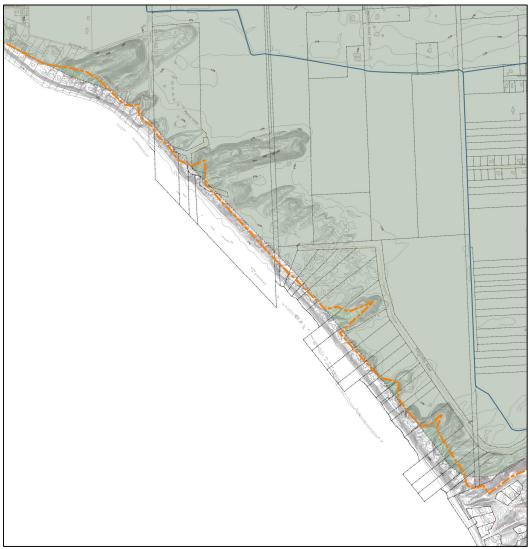
The boundary along the Lake Erie shoreline has been refined based on the contour lines but the change is not significant and follows mainly the original path.

Figure 17 Lake Erie Boundary

A change to relocate the boundary further west based on the NPCA contours was made.

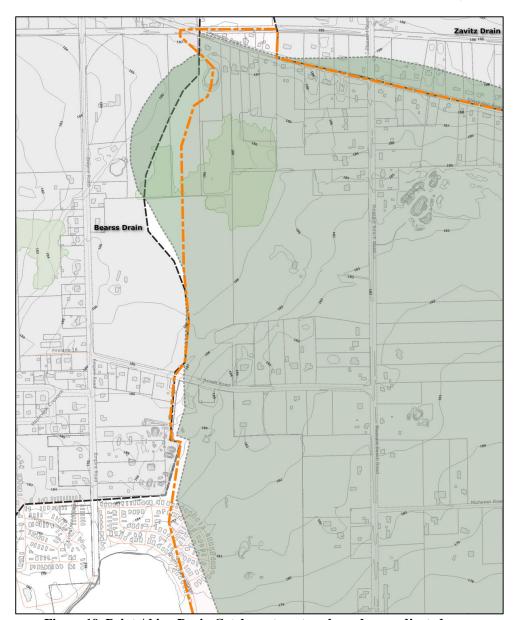
Figure 19 Point Abino Drain Catchment western boundary - adjusted

This boundary was adjusted west to the centreline of Shady Lane which as a roadway within Sherkston Sores is a constructed boundary based on the contour lines; 179, 178, 177 and 176. The end of the drain approaches the 176m boundary. The lowest surveyed bottom point for the drain end was 175.81m.

South of Sherkston Rd the contour line for 186m is used to align the breakline. The flow direction appears to be north and west based on the 186 to 185 lines west of the drawn boundary line. This reduces the former catchment to the east.

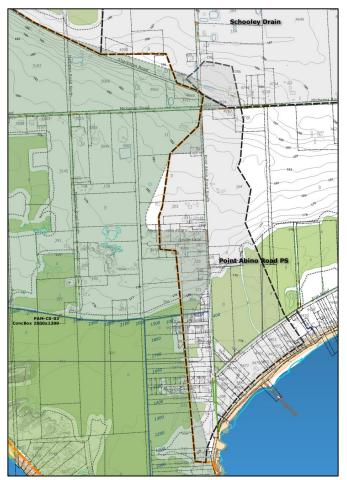
Currently the Town of Fort Erie is conducting a study of the Point Abino Rd Pumping Station. The first stage of this study is to define the catchment boundaries for which the pumping station is a receiver. Based on information provided by the Point Abino PS study, we have made the Point Abino Drain boundary coincident.

Figure 22 Point Abino Rd PS and eastern catchment boundary

The boundary as shown will be used for all future progress analysis and assessments; however, final updates will be based on the design data and information provided by the Town of Fort Erie.

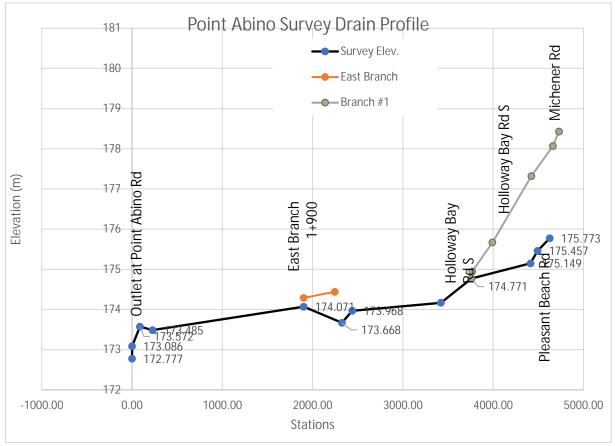
Figure 23 Point Abino Drain Profile

The Point Abino Drain Grade is distinct for the extremely low grade at the outlet, 0.04%.

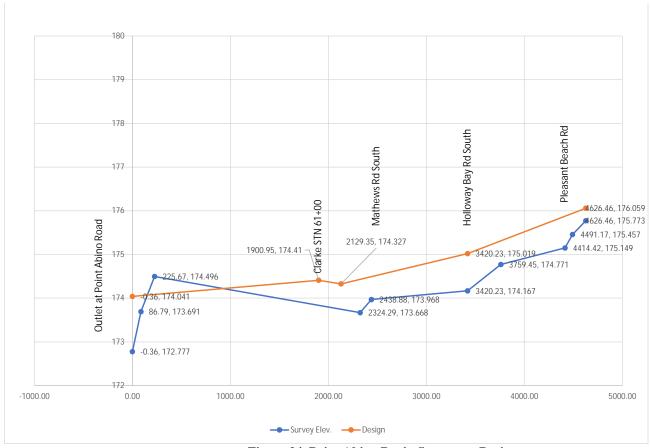
Figure 24 Point Abino Drain Survey vs. Design

From the history review conducted above, a review of the historical drainage design was prepared from the available technical information. The following chart shows the survey data collected and compared against the original design values.

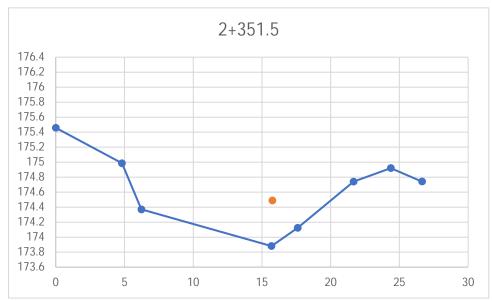
Figure 25 Cross-Section STA 2+351.5

To illustrate the impact that the Manning's n has on design capacity. The cross-section from the survey is as shown in the following figure.

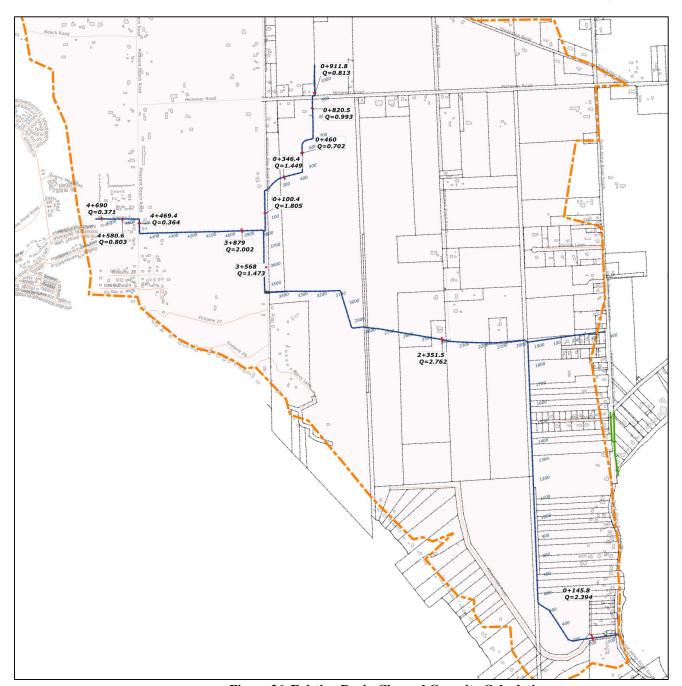
Figure 26 Existing Drain Channel Capacity Calculations

For the purposes of assessing the available channel capacity based on the survey data collected, we selected the following sections as typical for the drain and combined the data in spreadsheet (included in Appendix C) to calculate the capacity of each section using an 'n' value of 0.040.

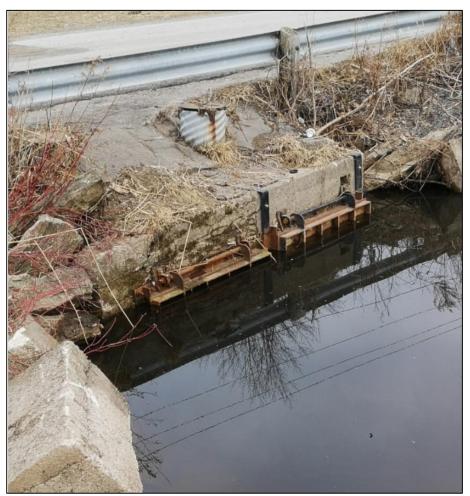
Figure 27 Point Abino Drain Outlet

The Point Abino Drain outlet is composed a twin culvert rectangular concrete box with a mounted steel flap gate on the face of the outlet.

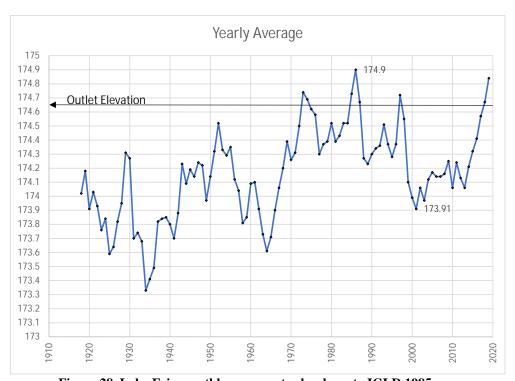
Figure 28 Lake Erie monthly mean water levels, m to IGLD 1985

The chart shows that for the past two years, water levels are above average conditions. Adding wave set up to this further influences the Point Abino Marsh Drain outlet.

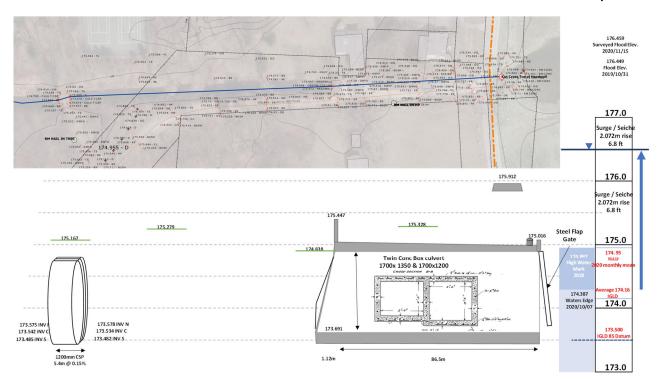
Figure 29 Point Abino Drain Outlet Structure with flap gate

Chart datum 173.5m + peak observed flow above datum 3.0m = 176.5m.

This is 0.7m higher than the top of the opening for the gate structure shown in the following diagram.

- 1. The barrier to the lake is only protected to the height of the road, which is 175.912m, nearly a metre less than the NPCA recommended 100 yr. flood level and 0.6m less than the recent storm surge in 2019/2020.
- 2. The existing concrete structure is recommended for replacement within 5 years at an estimated cost of \$2M. Prorating this cost on a per metre basis reveals that \$600,000 would be the portion assessed to the Town of Fort Erie

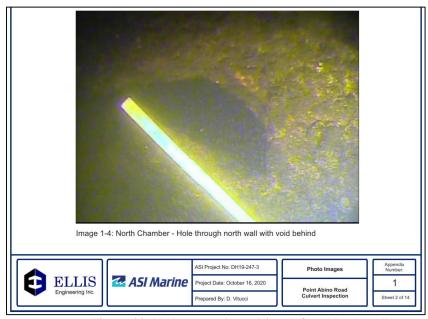
Figure 30 Underwater inspedtion defect North wall

- There are areas of cracking, spalling, concrete deterioration and exposed reinforcing steel in the north sidewall.
- There are voids in the north sidewall at 0+003 (approx.. 1m long, 0.3m high and 0.25m deep), 0+006 (approx.. 3m long1m long, 0.3m high and 0.25m deep), 0+065 (0.6m high and 0.25m deep), 0+070 (multiple locations 0.3m high and 0.25m deep), and 0+080 (1.5m long, 0.4m high and 0.25m deep). There are multiple areas of severe scour and voids in the north wall from 0+080 to 0+087.

- At 0+080 the hole in the north sidewall has a large void behind it and granular material was noted to be spilling into the culvert.
- There are multiple holes through the centre wall between 0.5m-1m long and 0.3m high at 0+012.

This underwater assessment identified several defects in the existing concrete structure. Defects such as holes in the concrete walls with soil voids detected.

The underwater dive inspection of Point Abino Road Bridge identified extensive areas of deterioration throughout the sidewalls and centre wall. Based on the findings, we recommend replacing the portion of the structure below the roadway allowance (24m in length from the east end) in 1-5 years. We recommend the west end of the structure (63m in length) be replaced or removed in 1-5 years. Due to the presence of multiple voids through the north sidewall, the roadway should be monitored for settlement or sinkholes until the structure is replaced.

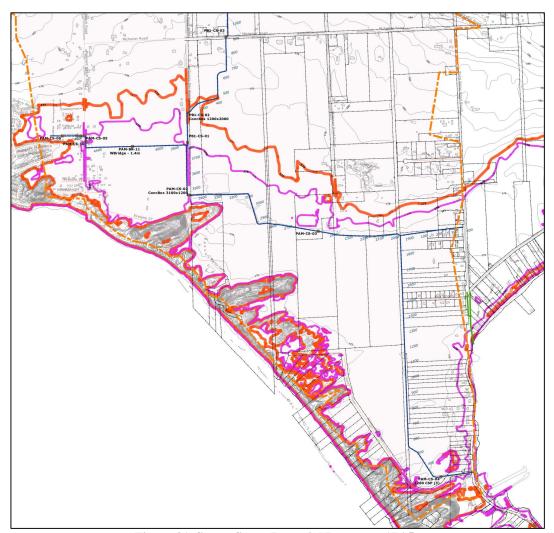
Figure 31 Storm Surge Potential Impact to 176.5m

To further demonstrate the key function of the control gate, the follow figure shows the contour lines of areas impacted by a storm surge of 176.5m by highlighting the NPCA contour lines 176.0 and 177.0.

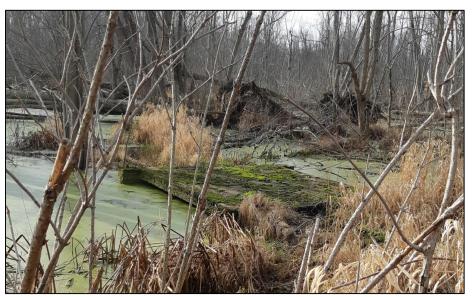
Figure 33 Mathews Rd S Drain Crossing PAM-CS-03

The existing culvert located on the drain for crossing the Mathews Rd. S ROW is shown but the function would appear to be compromised based on the photo collected in the fall of 2020.

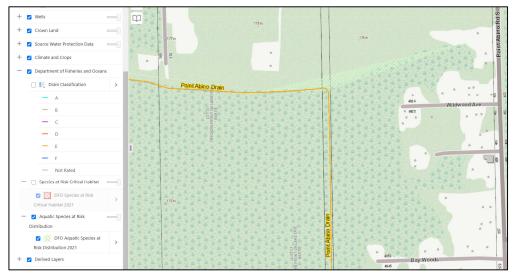
Figure 35 DFO Fisheries at Risk inventory

From this figure, there is an expectation of special measures or requirements to be addressed either by design or during construction for the protection of special significant species. This identifies two zones for GrassPickerel being of Special Concern, the upper watershed and the lower watershed being listed as two separate areas.

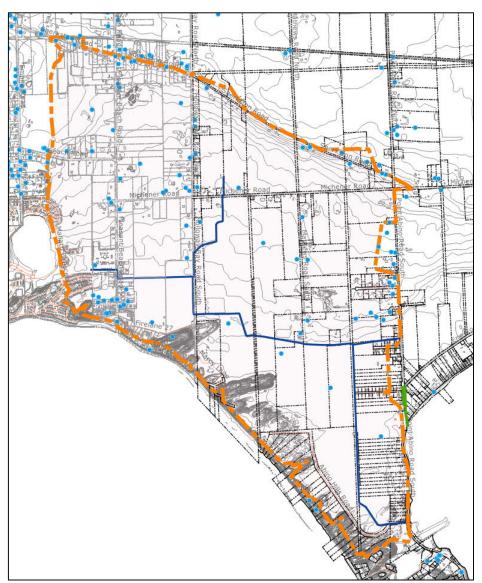
The following figure shows the placement of water well records within the area of drains.

Figure 40 Water Well Records

The presence of the overlying limestone series Onondaga, that is above a rock series that is very low permeability along with the parent soil material of predominately clay suggests that interactions with local municipal drains are unlikely to be a consideration for negative groundwater effects.
